Suspension Intervention

The path one man took to make his constant all-wheel-drive Nissan GTi-R handle like a car possessed. And you might be surprised to learn about the problems he encountered along the way...

By Michael Knowling.

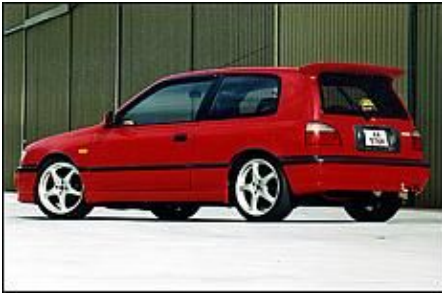
The stock 15-inch rims and tyres were discarded in favour for a set of hot-looking Viper A2 17x7s wearing Kelly Charger 215/40 rubbers. This particular choice of tyre was necessary because of financial limitations at the time, and their treadwear rating of 320 really is too high for this application. But Andrew plans to replace these with stickier tyres once the car is absolutely perfectly set up - if they ever wear out, that is! Interestingly, the front to rear tyre pressure balance is massively biased to the front. Around 44 psi goes into the front tyres while 30 psi goes into the rears - that's nearly 50% more at the rear. The aim of this is to further encourage the rear end to move slightly laterally through corners (reducing understeer).

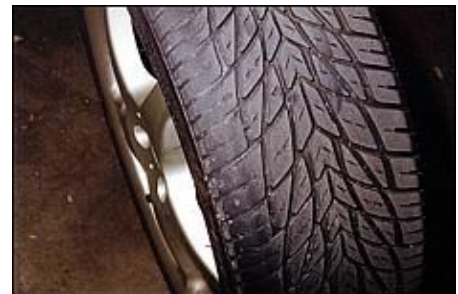
The problem was also causing massive wear on the outside shoulder of the tyres, as you can see.

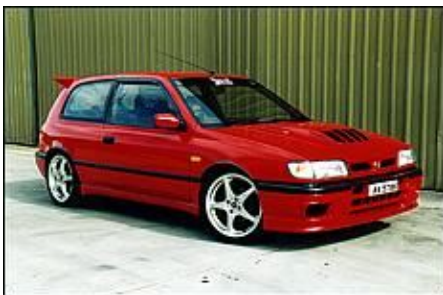
Turn in was further improved and understeer reduced by replacing the previous 18mm diameter rear swaybar with a solid KMAC part that measures 22mm. That means there are now 22mm swaybars fitted to the front and rear.

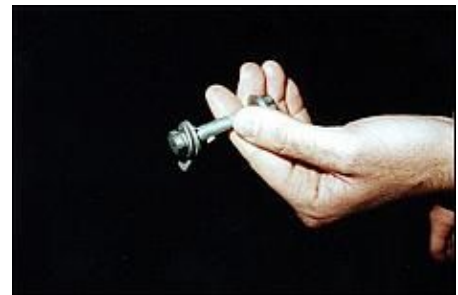
As the GTi-Rs camber bolts were being pulled out, the answer to the massive understeering problem suddenly smacked everyone watching in the face. Comparing the aftermarket top through-bolt to the factory through-bolt, it appeared the "high-performance" part was about half as thick!

These weak top bolts must have been flexing as soon as there was any real cornering load applied on the front wheels, thus causing the varying alignment angles.

A pair of quality K-MAC camber kits was subsequently purchased (part number 120116), and their packaging label confirmed Andrew's suspicions of the previous kit. They read "Safest to fit, no weakened crank bolts used, aircraft bolts used..." It certainly seems K-MAC had also become aware of some of the other low-quality aftermarket kits on the market!

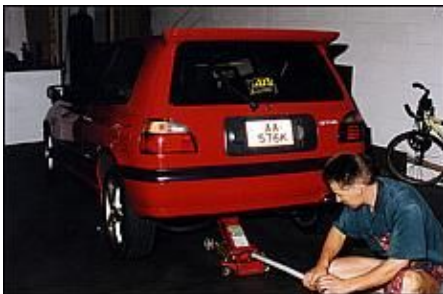
So out came the defective parts and in went the new K-MAC items. Bill Keen at ATS was entrusted with the task, and we went along to get some step-by-step photos of the event:

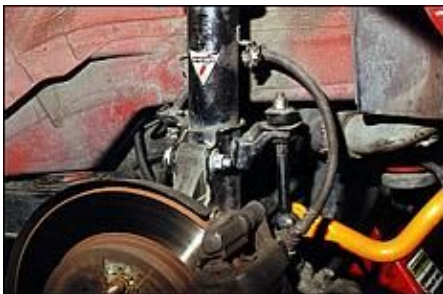
Firstly, the car was jacked off the ground.

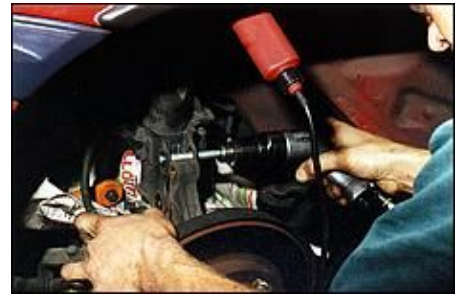
With the wheels removed, the culprit camber bolts were removed from each corner using spanners. As they were being slipped out of their hole, the aftermarket bolt had a large amount of clearance between itself and the inside of the hole. A sure sign the bolt was too flimsy for the job.

The standard lower hub bracket bolt was retained as no modification was required in this area.

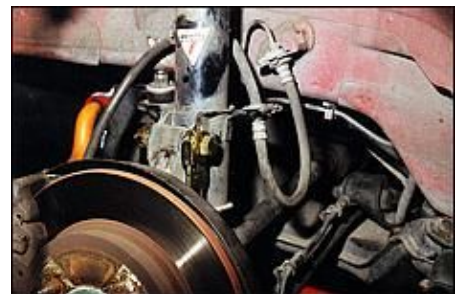
To fit the K-MAC camber kit, the top hole of the hub bracket was enlarged by a few millimetres using an electric drill. Bill of ATS made the point that when doing this, it is a good idea to lay out newspaper underneath to protect ABS sensors and driveshaft boots from the filings. The rough edges of the hole were then cleaned up.
